## Roofing Report: <Address>

## 1. Scope of Reporting

The purpose of this report is to provide feedback on the overall condition of all roofing areas at [REDACTED]

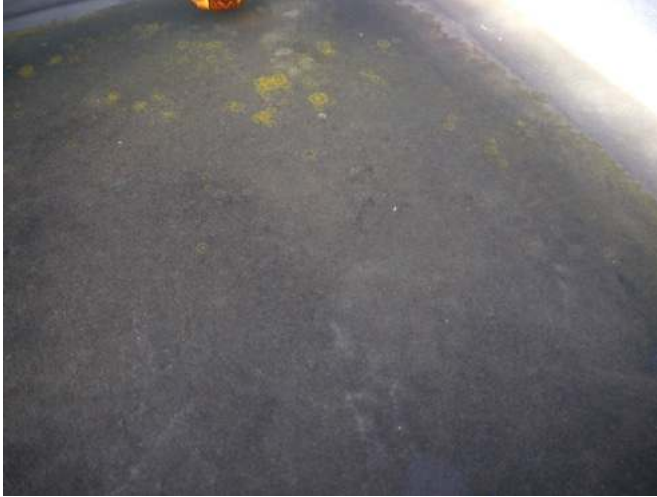
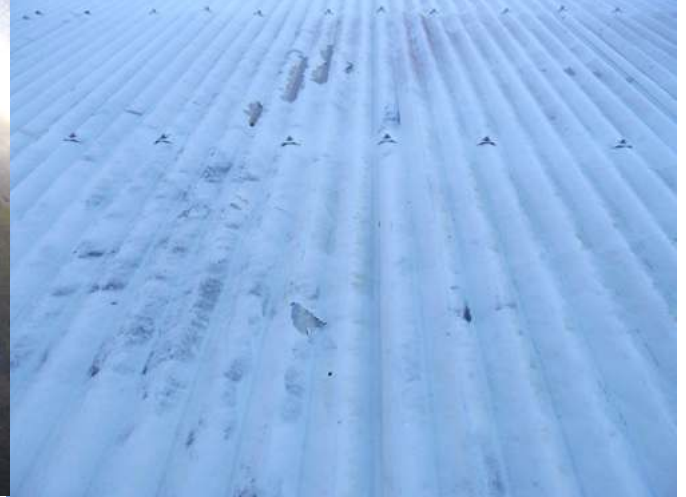
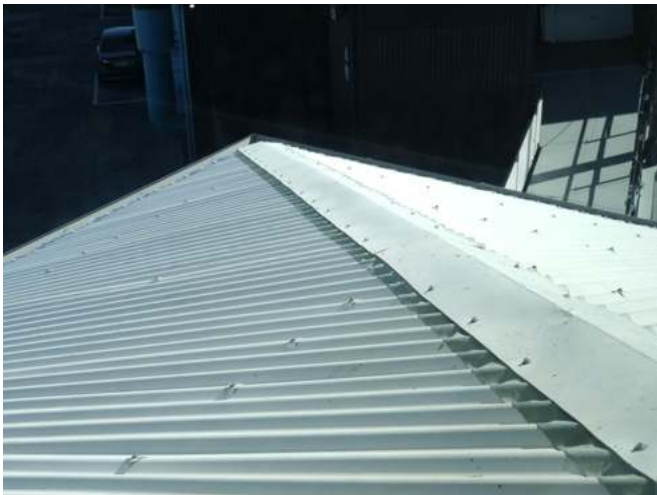
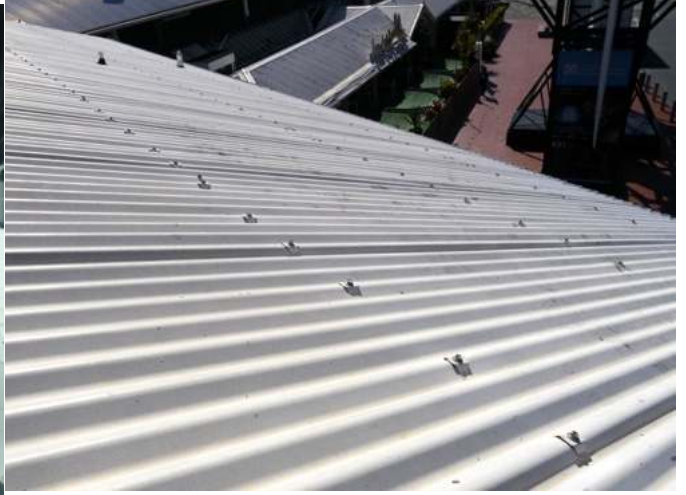
**General Feedback:** This roofing area is in good condition, was very well installed and has no obvious waterproofing issues. The guttering looks brand new and the ends of the sheets have been trimmed and undersheeted recently (presumably as they rusted).

**Structural Feedback:** This roofing area is robust and has no areas of structural weakness. The bitumen roofing section at the top of the turret is firm and in good condition and doesn't require re-plying in the medium to long term as it appears to be lasting very well.

**Aesthetic Feedback:** This roof generally looks good, there are some discolourations, marks from people walking on the roof and small areas of chipped off / peeling paint (as photographed). The screw heads and saddles have tiny surface rust but this is normal and purely aesthetic. There is a small amount of rust on the edges of the sheets (lateral laps) but this is normal for a roof this age. There are some small splatterings of silicone and other splatters of asphalt or construction material from previous tradesmen but nothing major.

**Timeframe and recommended works:** We recommend the condition of the roof is monitored and painting is undertaken at approximately the 2.5 year mark. This will ensure the roof looks good on the frontage for the next 10/15 years and mitigate the exposure of the iron where the paint has peeled off (not a good sign as rust will most likely arrive next if left unattended).

**Pricing Estimates:** This painting job could be undertaken off a scissor lift

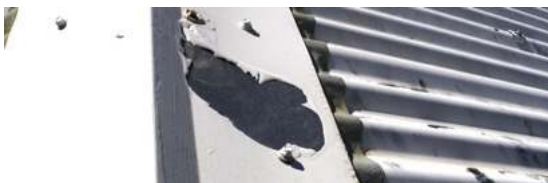
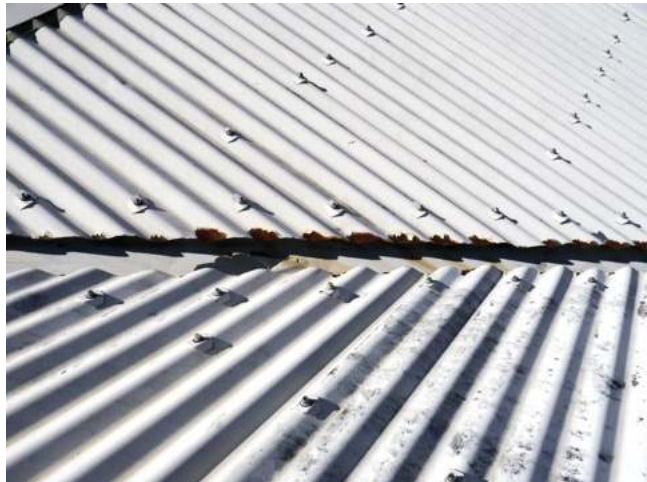
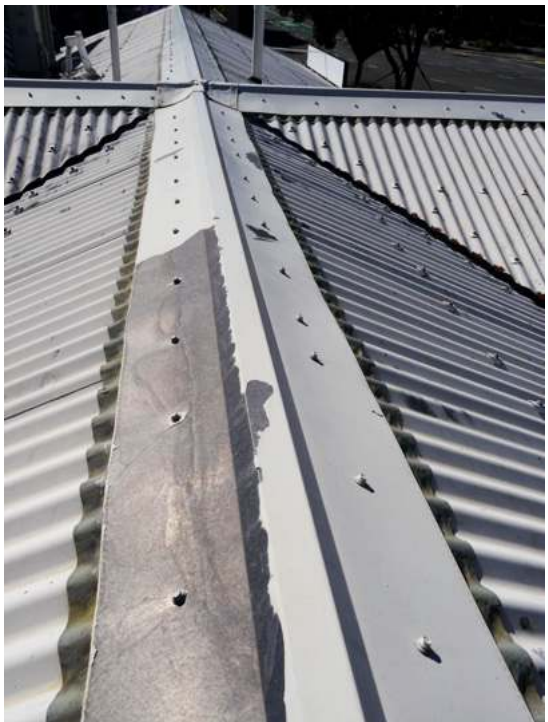
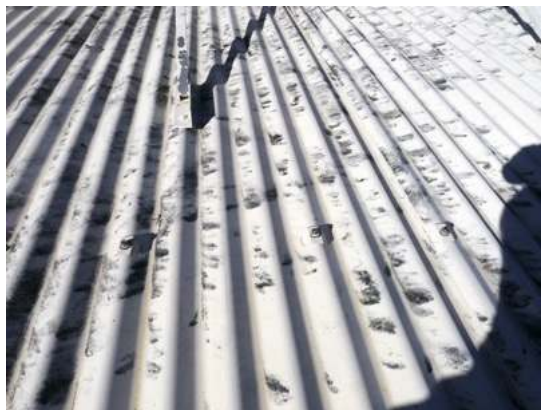
**General Feedback:** This roofing area is in poor overall condition and may have some waterproofing issues. This roofing area has been installed in a somewhat mediocre and haphazard way and has not aged particularly well. The gutters are in fair condition and it looks like the roof has been painted in the last 5 years but this is now starting to peel off. This roof appears to be coming to the end of its natural lifespan and should be replaced inside the next 5 years.

**Structural Feedback:** There are significant rusted areas that are compromising the structural integrity and parts of the iron feel soft underfoot (indicating weakness).

**Aesthetic Feedback:** This roof has a poor aesthetic finish with significant structural and surface rusting, lots of rusting on the edges of sheets and lots of peeling paint. There are also lots of marks from tradesmen accessing the roof and some concrete splatters from roading work and a fair amount of other blemishes from unknown sources. All in all a shabby looking roof, especially for the frontage of the building as highly visible.

**Timeframe and recommended works:** This roof will undoubtedly need to be fully replaced in the next 5 years. Provided there are no urgent waterproofing concerns and you can tolerate the appearance of it currently; this work is not urgent but spending any money at this late stage on repainting or trimming and undersheeting to remove the rust would be a waste of resources. We recommend that no other money is spent in the ongoing maintenance or rehabilitation of the roof until you find it either convenient to preemptively replace it or a significant waterproofing issue arises and you have no choice. 5 years would be an optimistic assessment of how much longer this roof could last prior to full replacement; there is a decent argument for replacing it preemptively right away however technically speaking it can last longer, unattractive as it may be.

**Pricing Estimates:** Full replacement is the recommended course of action, see Replacement cost estimate above.

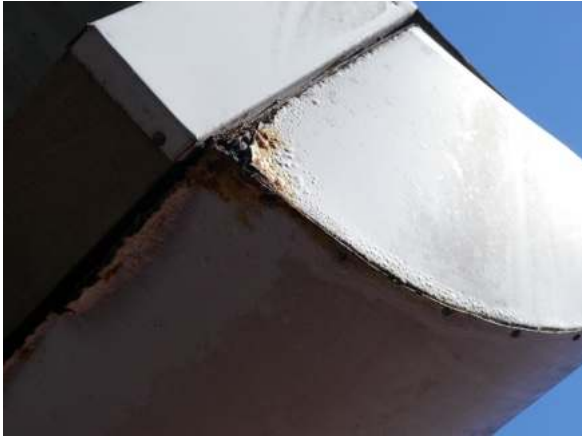
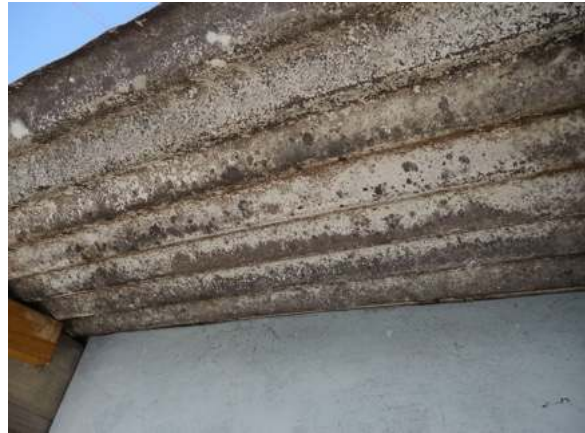
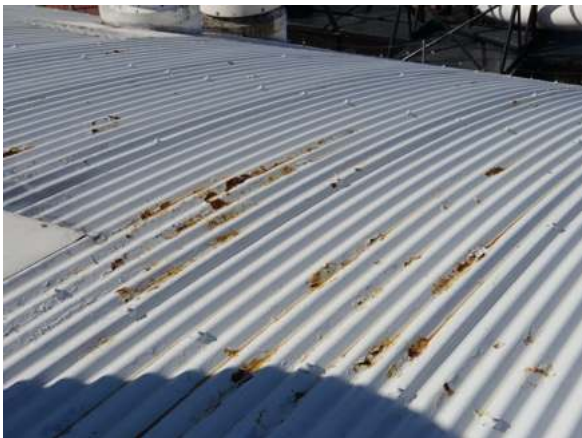
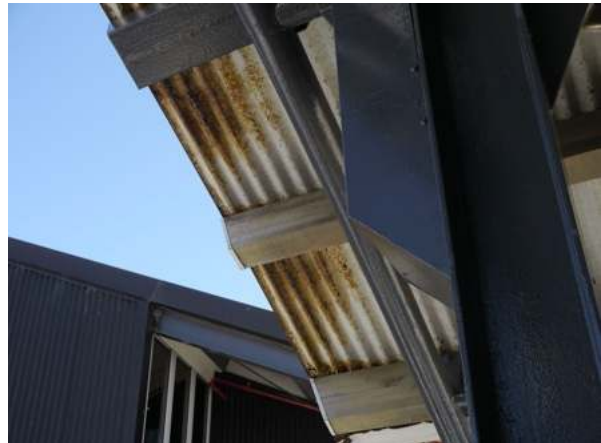
**General Feedback:** This roofing area is in extremely poor condition and requires immediate replacement before major waterproofing issues arise; it is miraculous the entire building is not currently leaking like a sieve.

The guttering on the ocean facing side is totally rusted out however the road-side guttering is in good condition.

**Structural Feedback:** This roofing area is structurally poor. The rust is significant, prolific and has penetrated right through the iron in many places to the underside. The iron is soft underfoot (a sign of critical weakness). Total failure of this roofing material is imminent.

Aesthetic Feedback: This roofing area is in terrible aesthetic condition and has significant rust throughout. It appears to have been painted in the last 5 years however this paint is peeling; giving a general look of patchiness and rust.

**Timeframe and recommended works:** Immediate replacement is the only viable course. No work is required on the guttering for the road-side however on the ocean facing side the gutter should receive the same marine grade rust treatment as the structural steel visible at other locations at the facility (this will be the most economical way to deal with this gutter as it will be extremely expensive to replace).

**Pricing Estimates:** Full replacement is the only viable course. See Replacement cost estimate above.

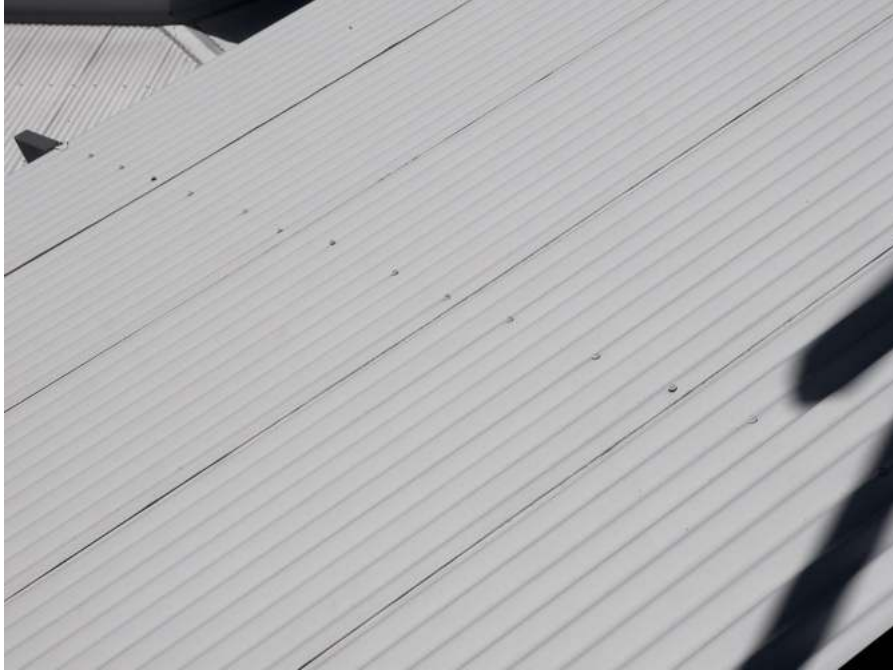
**General Feedback:** This roofing area is near new, was installed very well and is in perfect condition.

**Timeframe and recommended works:** No works are recommended over the timeframe considered in this report. The condition of the roof should be checked after 10 years and painting could be considered at this point in time.

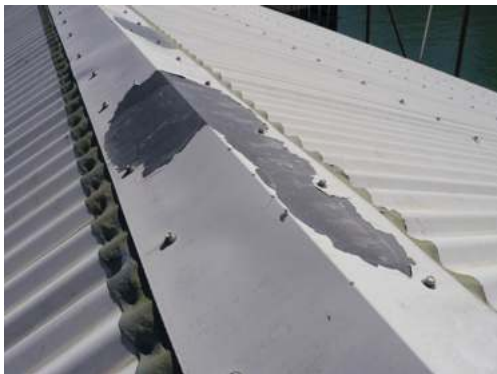
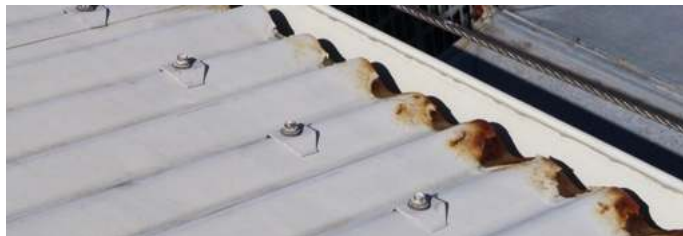
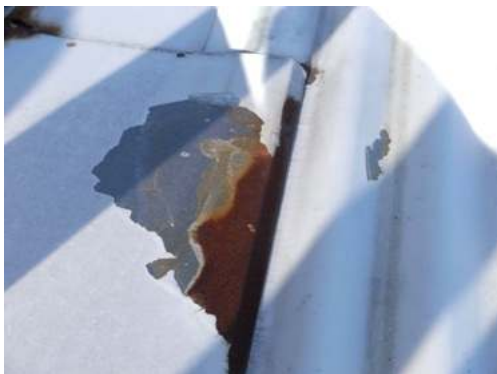
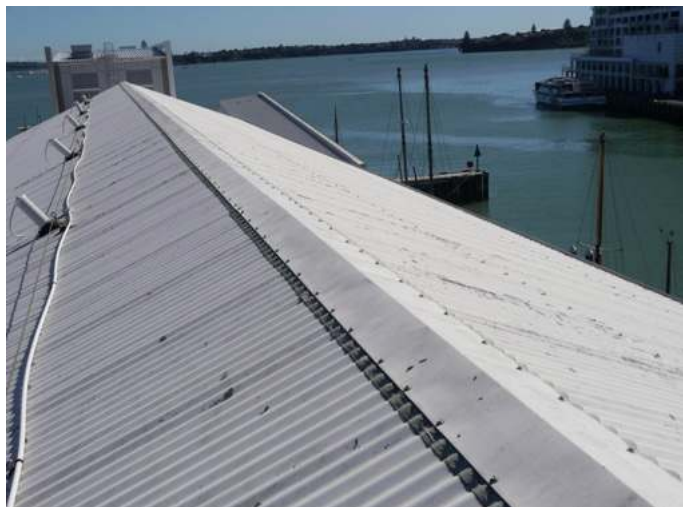
**General Feedback:** This large roofing area is in mediocre condition and has been installed fairly well, but not perfectly. The gutters are in fair condition. It appears to have no imminent waterproofing issues however these may arise in the short to mid term. There are signs of deterioration and some preemptive actions to mitigate worsening of this is recommended.

**Structural Feedback:** This roofing area has no structural concerns and is robust, the rust on the ends of the sheets should be addressed before it spreads up the sheets and affects the structural integrity of the iron. The roof appears waterproof and is strong; it will last a long time.

**Aesthetic Feedback:** This roofing area is in poor aesthetic condition. There are significant areas of paint deterioration and flaking, along with rust and degradation especially around some flashings and at the edges of the sheets. There are a lot of black smears from people walking on the roof, concrete flecks and other blemishes. Overall the roof does not look great but is up high, so is not visible from anywhere public at the facility.

**Timeframe and recommended works:** It is recommended that these sheets are all trimmed, undersheeted and marine painted (as with the sheets in Zone 1), this could be delayed a few years maximum but should be undertaken soon before the rust spreads too high up the sheet, if the rust gets up too high above the first row of screws this method of addressing the rust will be unavailable to resolve the issue. In addition for longevity and aesthetic benefits this whole roof should be repainted in the next 5 years, probably at the same time as the undersheeting. Could be done now, should be done at the 2.5 year mark and 100% needs to be done by the 5 year mark.

**Pricing Estimates:** \$55,200 water-blasting, rust treatment, painting prep, then marine grade painting.

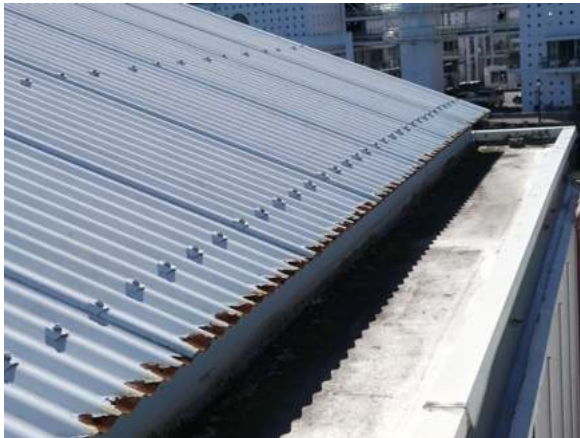
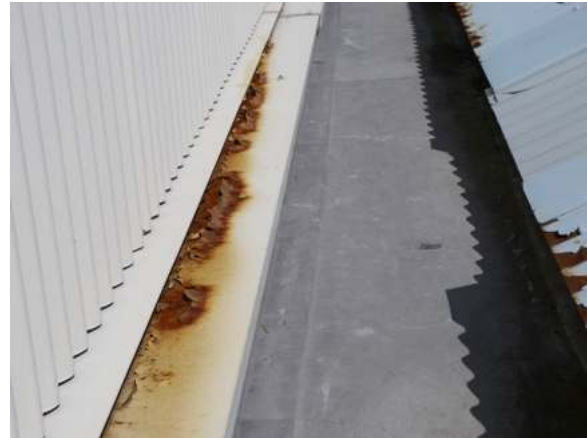
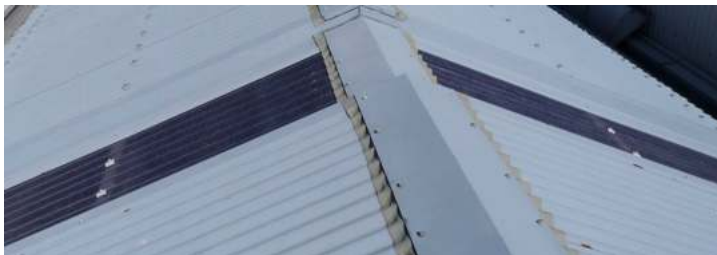
**General Feedback:** These two roofing areas are new, installed very well and overall are in good condition. The membrane gutters and clear sheets are in excellent condition and except for some rust on the ends of the sheets and one very rusty flashing (shown above) the area is generally very good.

**Structural Feedback:** This roofing area has no structural concerns and is very robust, the rust on the ends of the sheets should be addressed before it spreads up the sheets and affects the structural integrity of the iron.

**Aesthetic Feedback:** Other than the rust on the ends of the sheets and 1 very rusty flashing (shown above) this roof is in excellent aesthetic condition and does not require painting or replacement in the medium to long term.

**Timeframe and recommended works:** It is recommended that these sheets are all immediately trimmed, undersheeted and marine painted (as with the sheets in Zone 1), this could be delayed a few years maximum but should be undertaken soon before the rust spreads too high up the sheet, if the rust gets up too high above the first row of screws this method of addressing the rust will be unavailable to resolve the issue, so the sooner the better. No other works are recommended on this roofing area over the timeframe considered in this report.

**Pricing Estimates:** Trimming, undersheeting and painting should be easy for this roofing area as there is no scaffolding or access requirements; the workers can stand in the membrane gutter and complete this work easily. On the ends near the edges we propose that installing static lines for safety would be the easiest and most cost effective access solution and be of long term benefit for works in the future too.

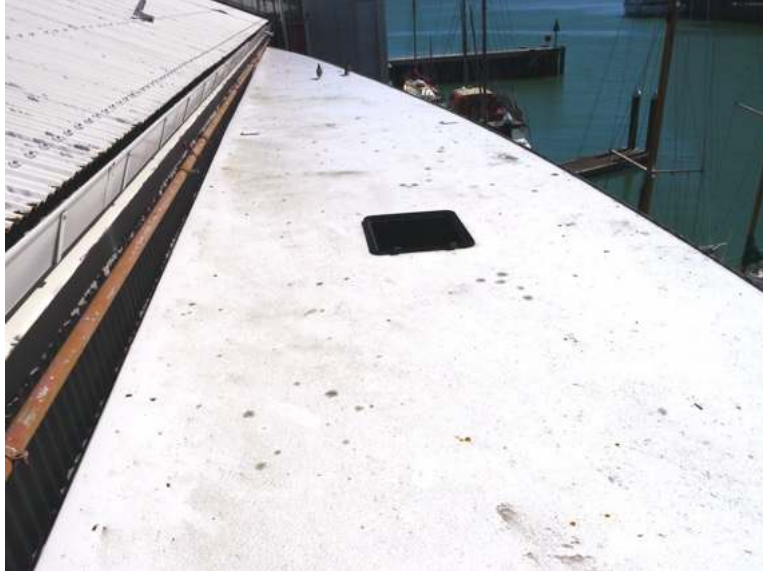
**General Feedback:** This roofing area is in perfect condition and was installed very well.

**Structural Feedback:** This roof is structurally very sound and in excellent condition.

**Aesthetic Feedback:** There is some moss and lichen on this roof that should be removed, other than that it looks good.

**Timeframe and recommended works:** This roofing area should be water blasted now to remove the moss and lichen other than that, no works are recommended over the timeframe considered in this report. The condition of the roof should be checked after 10 years and painting could be considered at this point in time.

**Pricing Estimates:** Waterblasting the small roofing area \$1725

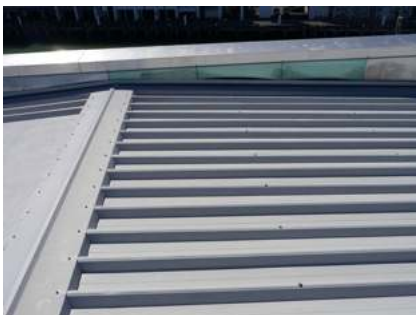
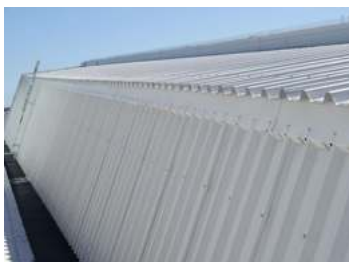
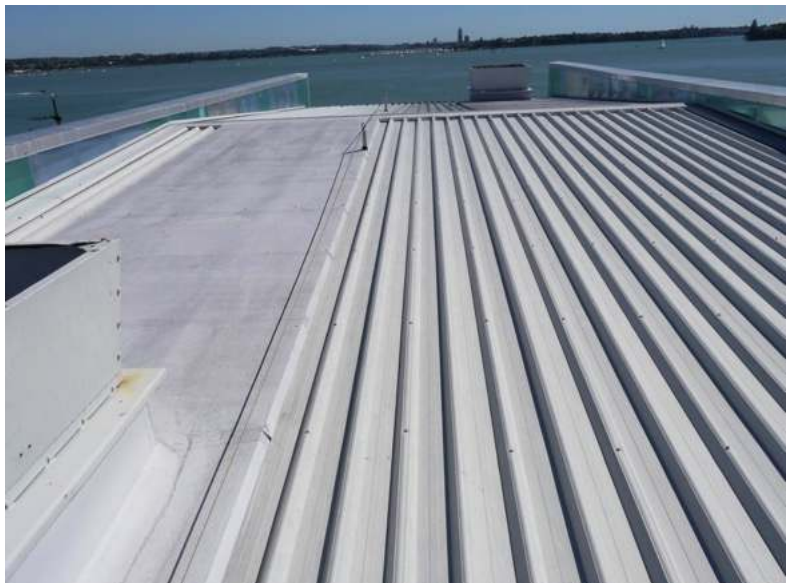
**General Feedback:** This roofing area is near new, was installed perfectly and is in excellent condition.

**Timeframe and recommended works:** No works are recommended over the timeframe considered in this report. The condition of the roof should be checked after 10 years and painting could be considered at this point in time.
