## Roofing Report: <Address>

## 1. Scope of Reporting

The purpose of this report is to provide feedback on the overall condition of all roofing areas at [REDACTED]

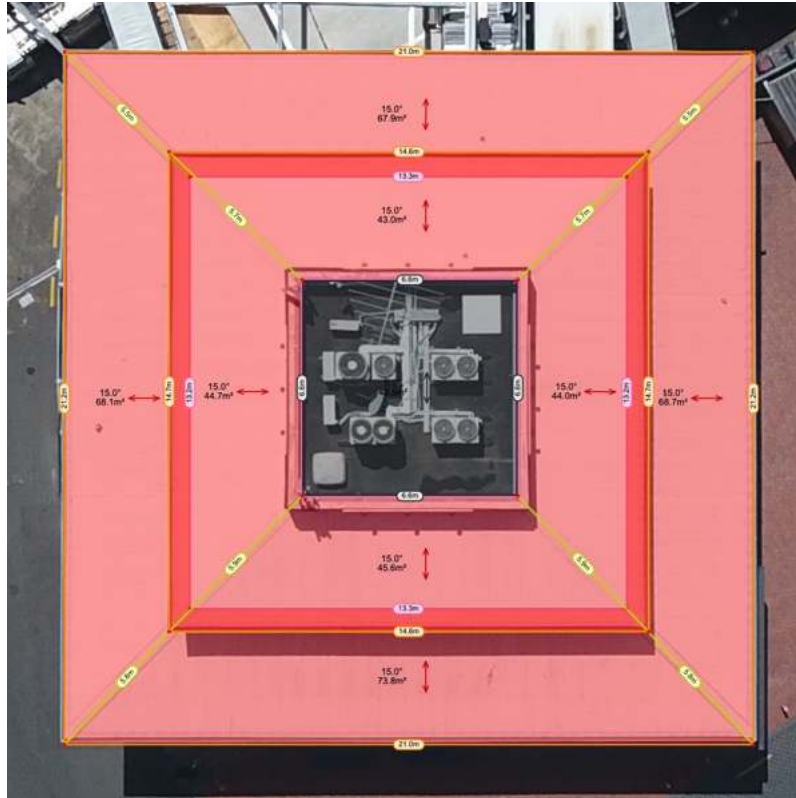
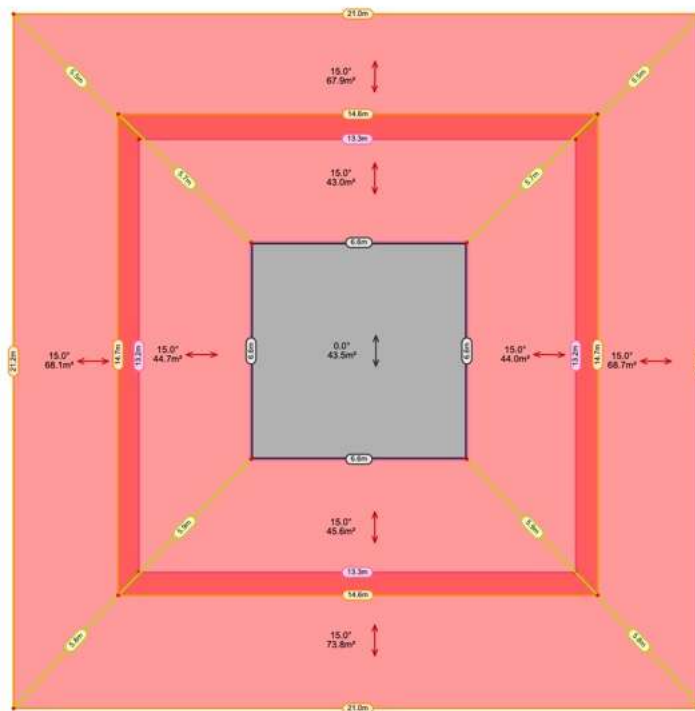
### 3. Zone 1 Analysis

**General Feedback:** This roofing area is in good condition, was very well installed and has no obvious waterproofing issues. The guttering looks brand new and the ends of the sheets have been trimmed and undersheeted recently (presumably as they rusted).

**Structural Feedback:** This roofing area is robust and has no areas of structural weakness. The bitumen roofing section at the top of the turret is firm and in good condition and doesn't require re-plying in the medium to long term as it appears to be lasting very well.

**Aesthetic Feedback:** This roof generally looks good, there are some discolourations, marks from people walking on the roof and small areas of chipped off / peeling paint (as photographed). The screw heads and saddles have tiny surface rust but this is normal and purely aesthetic. There is a small amount of rust on the edges of the sheets (lateral laps) but this is normal for a roof this age. There are some small splatterings of silicone and other splatters of asphalt or construction material from previous tradesmen but nothing major.

**Timeframe and recommended works:** We recommend the condition of the roof is monitored and painting is undertaken at approximately the 2.5 year mark. This will ensure the roof looks good on the frontage for the next 10/15 years and mitigate the exposure of the iron where the paint has peeled off (not a good sign as rust will most likely arrive next if left unattended).

\$25,300 waterblasting, rust treatment, painting prep, then marine grade painting.

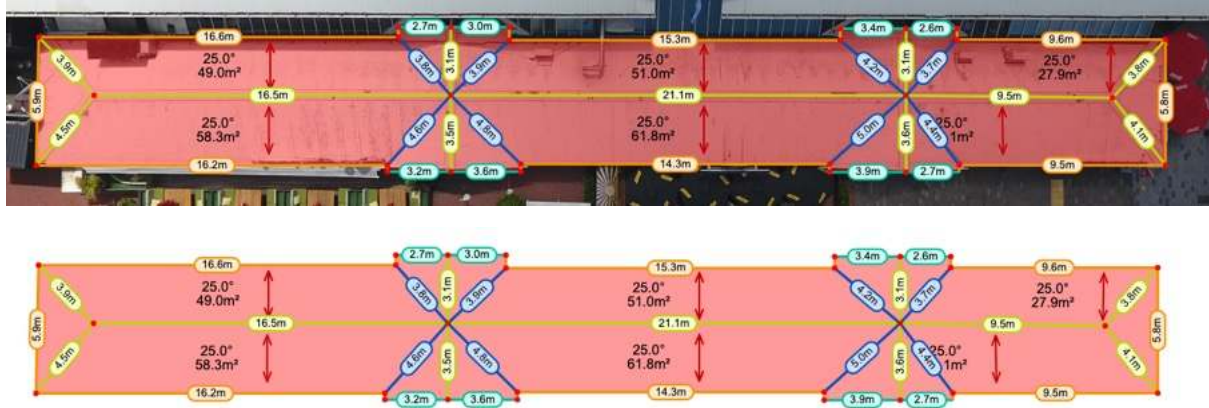
## 4. Zone 2 Analysis

**General Feedback:** This roofing area is in poor overall condition and may have some waterproofing issues. This roofing area has been installed in a somewhat mediocre and haphazard way and has not aged particularly well. The gutters are in fair condition and it looks like the roof has been painted in the last 5 years but this is now starting to peel off. This roof appears to be coming to the end of its natural lifespan and should be replaced inside the next 5 years.

**Structural Feedback:** There are significant rusted areas that are compromising the structural integrity and parts of the iron feel soft underfoot (indicating weakness).

**Aesthetic Feedback:** This roof has a poor aesthetic finish with significant structural and surface rusting, lots of rusting on the edges of sheets and lots of peeling paint. There are also lots of marks from tradesmen accessing the roof and some concrete splatters from roading work and a fair amount of other blemishes from unknown sources. All in all a shabby looking roof, especially for the frontage of the building as highly visible.

**Timeframe and recommended works:** This roof will undoubtedly need to be fully replaced in the next 5 years. Provided there are no urgent waterproofing concerns and you can tolerate the appearance of it currently; this work is not urgent but spending any money at this late stage on repainting or trimming and undersheeting to remove the rust would be a waste of resources. We recommend that no other money is spent in the ongoing maintenance or rehabilitation of the roof until you find it either convenient to preemptively replace it or a significant waterproofing issue arises and you have no choice. 5 years would be an optimistic assessment of how much longer this roof could last prior to full replacement; there is a decent argument for replacing it preemptively right away however technically speaking it can last longer, unattractive as it may be.

**Pricing Estimates:** Full replacement is the recommended course of action, see Replacement cost estimate above.

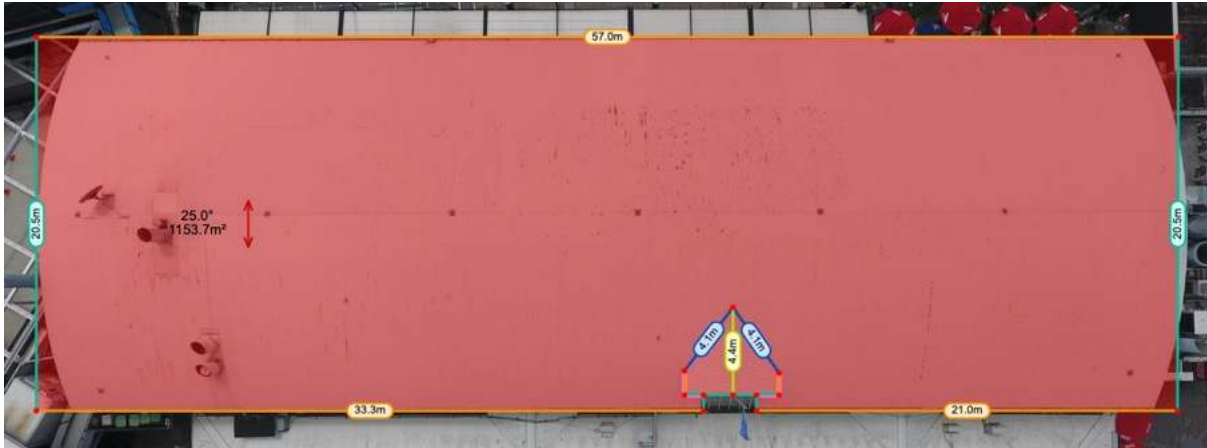
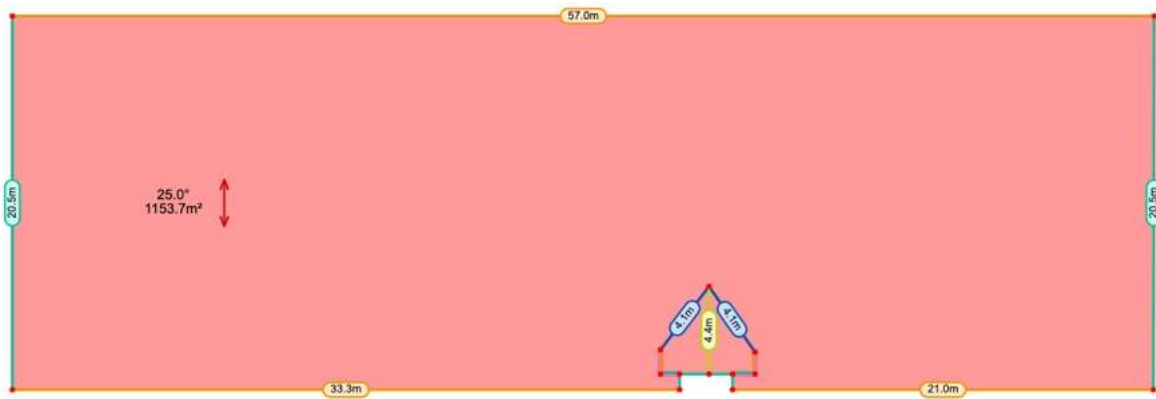
## 5. Zone 3 Analysis

**General Feedback:** This roofing area is in extremely poor condition and requires immediate replacement before major waterproofing issues arise; it is miraculous the entire building is not currently leaking like a sieve.

The guttering on the ocean facing side is totally rusted out however the road-side guttering is in good condition.

**Structural Feedback:** This roofing area is structurally poor. The rust is significant, prolific and has penetrated right through the iron in many places to the underside. The iron is soft underfoot (a sign of critical weakness). Total failure of this roofing material is imminent.

Aesthetic Feedback: This roofing area is in terrible aesthetic condition and has significant rust throughout. It appears to have been painted in the last 5 years however this paint is peeling; giving a general look of patchiness and rust.

**Timeframe and recommended works:** Immediate replacement is the only viable course. No work is required on the guttering for the road-side however on the ocean facing side the gutter should receive the same marine grade rust treatment as the structural steel visible at other locations at the facility (this will be the most economical way to deal with this gutter as it will be extremely expensive to replace).
